Aircraft Industries

MANDATORY BULLETIN

MB No: L13/116a

Subject: Check of the mechanical characteristics of the material the upper and lower spar cap.

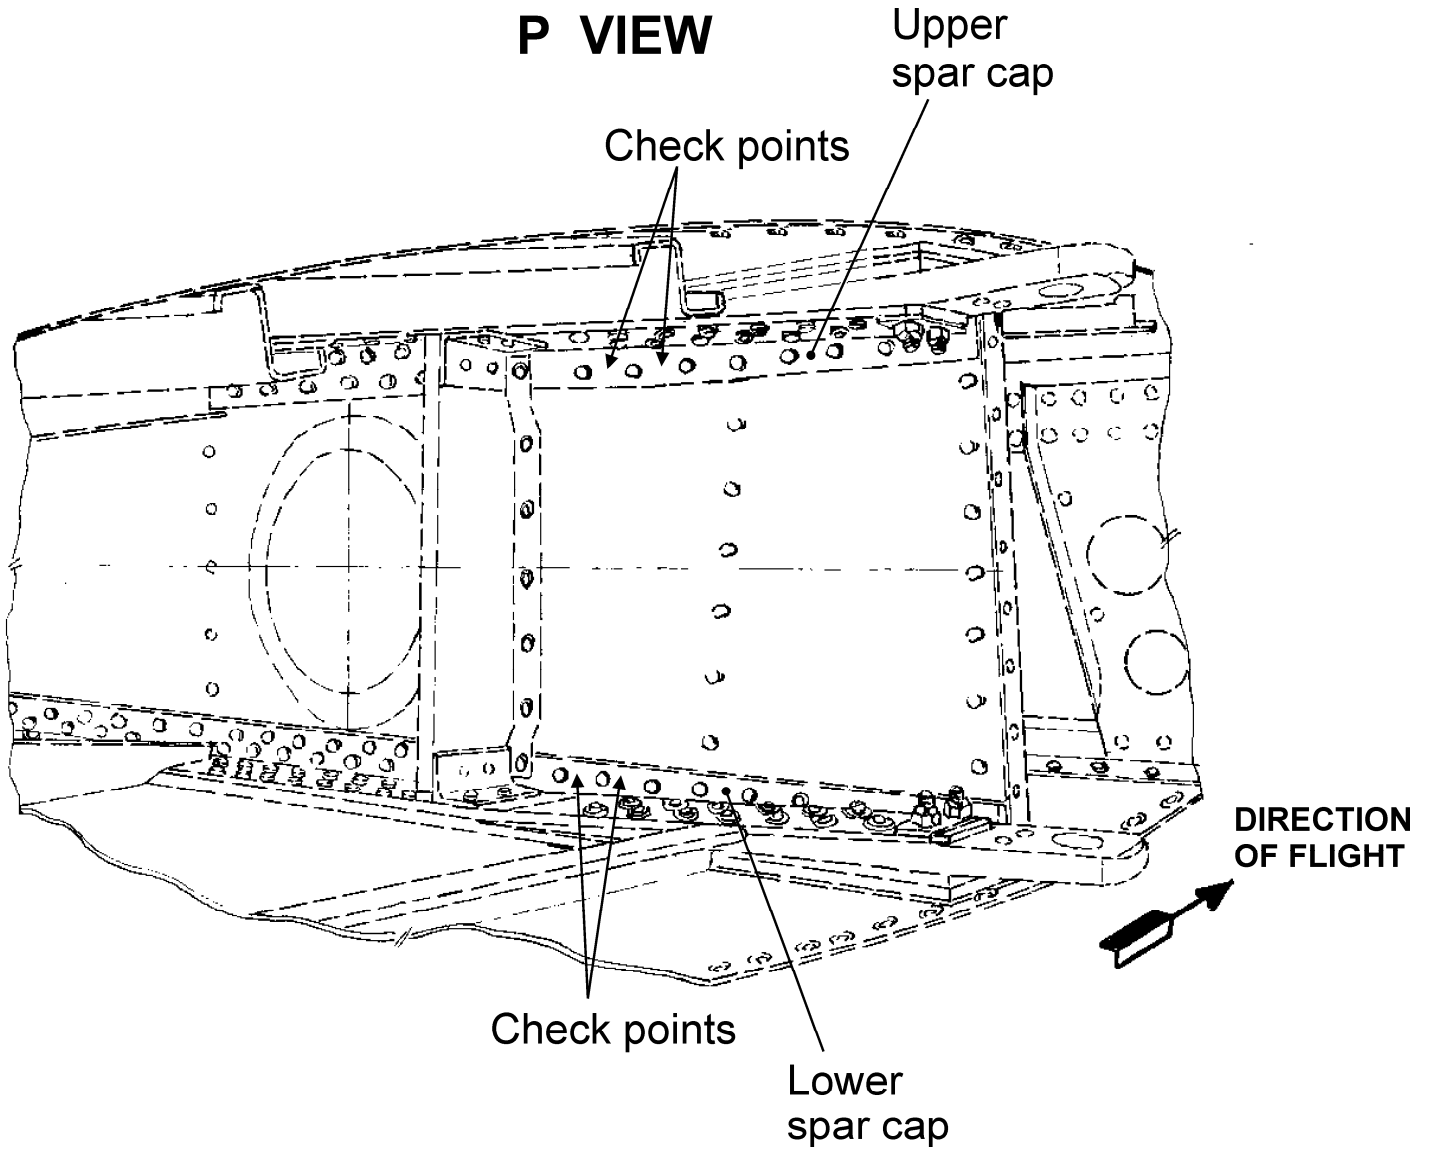
Fig. 2 - Check points on the upper and lower spar cap

3. Through a access hole, perform the check of the mechanical characteristics of the material the upper and lower spar cap as follows:
 - a. Before the check, clean the dirt and grease from the controlled space, using appropriate preparations.
For check is accessible the vertical part of the spar cap, adjacent to the spar - refer to the fig. 2.
Carry out the check in the areas described on the fig. 2.

- Measuring contact points: upper and lower spar cap (between rivets) - refer to the fig. 2.
 - c. Permissible range of measured value

% IACS (International Annealed Copper Standard)
28.5 - 34.0
 - d. Repeat the measurements several times for verify the results, in the several areas described on the fig. 2.
 - e. Any other measuring method must be approved by the sailplane manufacturer before it can be used.

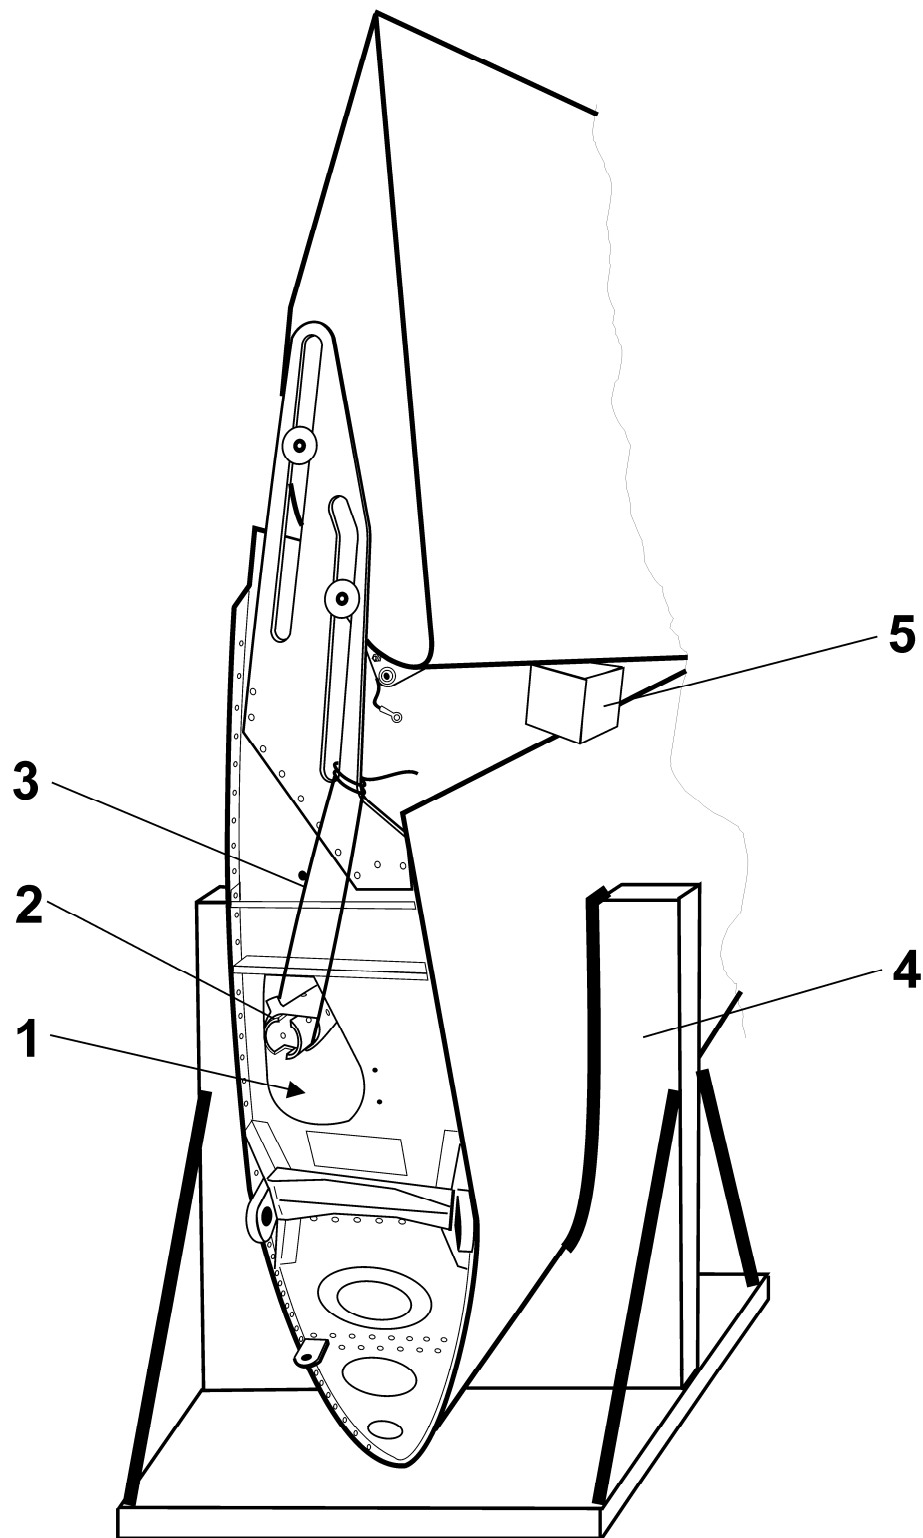
Fig. 3 - View of the prepared wing on the check

- (1) Access to the check;
- (2) Drive shaft of wing and brake flaps in wing;
- (3) Binding wire;
- (4) Suitable rack;
- (5) Suitable pads

1. Remove the LH and RH wing from the sailplane.
Put the removed wings into the vertical position into the racks prepared beforehand
- see fig. 3.
2. Perform the following procedures for assurance of access to check points:
